Manhole Inspection Summary

Manhole # S41KK_018MH

Insp Date: **9/1/09 2:25 PM**

Location Address: **1500 LAFAYETTE AVE**

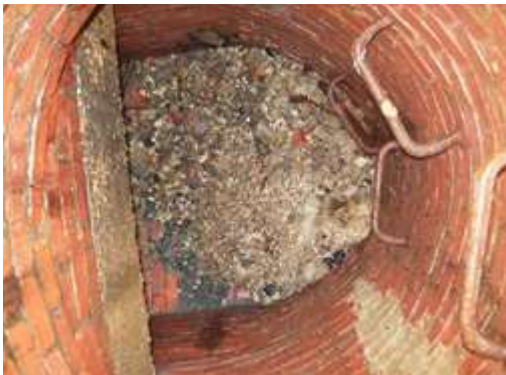
Top View

FULL OF DEBRIS

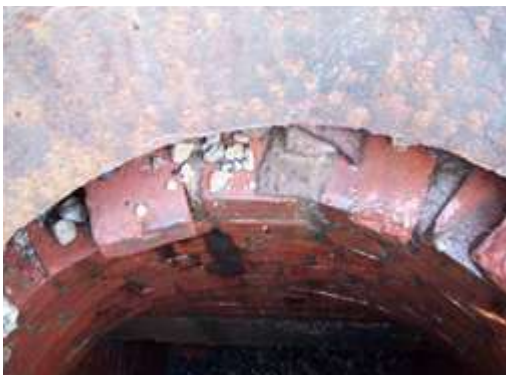
Defect 1

Condition: ☐ Sound ☐ Cracked ☐ Root Intrusion ☒ **Loose Brick** ☐ Deteriorated

CHIMNEY LOOSE BRICKS

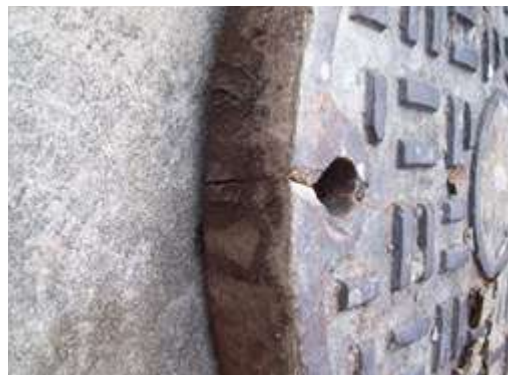
Defect 4

Type: **Sanitary** Condition: **Cracked** Cover Material: **Cast Iron**

CRACKED COVER

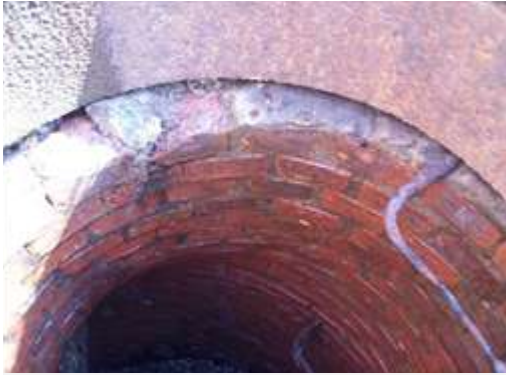
Defect 2

Frame Offset: **2** (in.) Condition: ☒ Sound ☐ Cracked ☐ Leaks

Steps Count: **5** Missing: **0** ☒ **Corroded**

FRAME OFFSET/ STEPS CORRODED

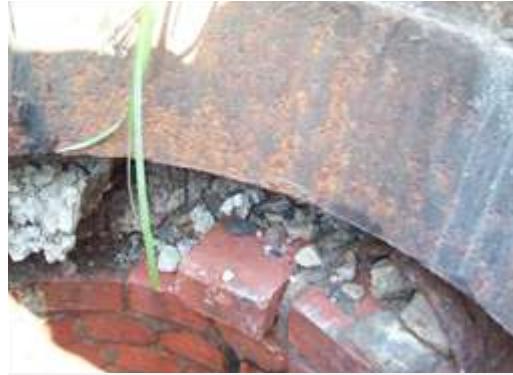
Defect 7

CRACKED CHIMNEY

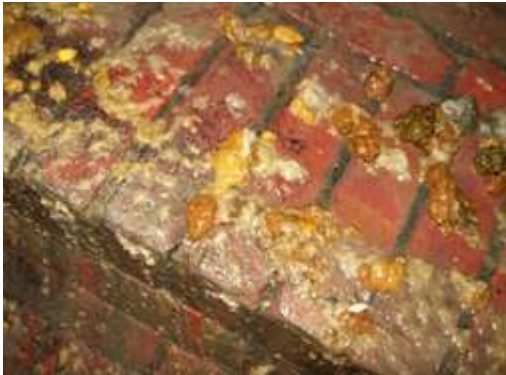
Defect 6

Surcharge ☒ **Evidence Of Surcharge** Depth: **7.2** (ft.) ☐ Active Surcharge Present

EVIDENCE OF SURCHARGE

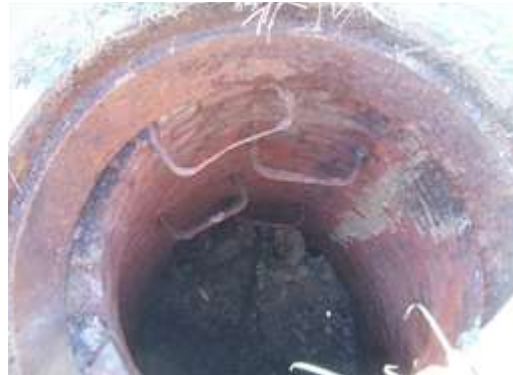
Defect 5

CORROED STEPS

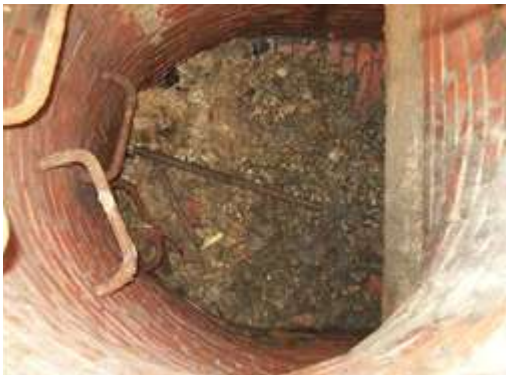
Defect 4

DEBRIS ON BENCH

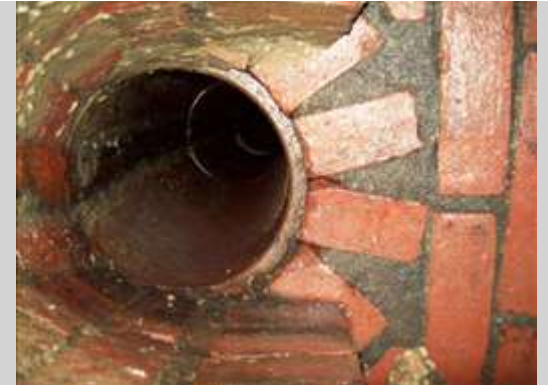
12 O'Clock Outflow

8 in. Circular Gravity Sewer
Pipe Out @ 12 O'Clock

Pipe Height: (in.) Direct
Pipe Material: **Clay** ☐ Pipe Lined
Invert Depth: **8.52** (ft.) Flow Characteristics: **Slow**
Deposits: ☒ None ☐ Mud ☐ Sludge ☐ Debris ☐ Grease
Silt Depth: (in.) Deposits Extent:
Infiltration: **None** Pipe Seal Cond: **Sound**

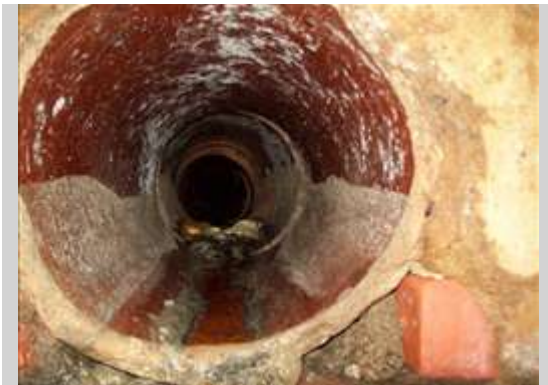
6 O'Clock Inflow

8 in. Circular Gravity Sewer
Pipe In @ 6 O'Clock

Pipe Height: (in.) Direct
Pipe Material: **Clay** ☐ Pipe Lined
Invert Depth: **5.12** (ft.) Flow Characteristics: **Slow**
Deposits: ☒ None ☐ Mud ☐ Sludge ☐ Debris ☐ Grease
Silt Depth: (in.) Deposits Extent:
Infiltration: **None** Pipe Seal Cond: **Sound**

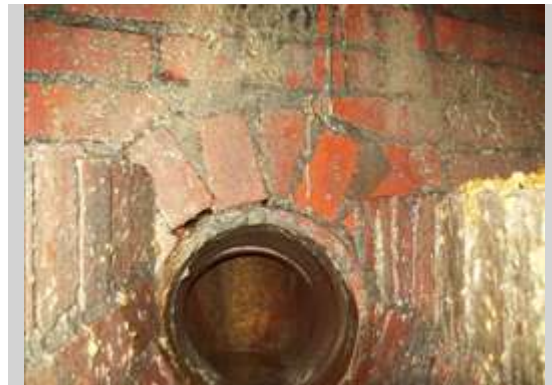
Drop In @ 6 O'Clock

Drop: **Outside Direct**
Angled: Reading: (ft.)
Inv Depth: **8.36** (ft.)
Drop Condition: **Open**
